Laser Induced Damage

A WAY FOR AN EFFECTIVE
AND RELIABLE USE
OF A NEW GENERATION
HIGH-INTENSITY LASERS

WHITE PAPER

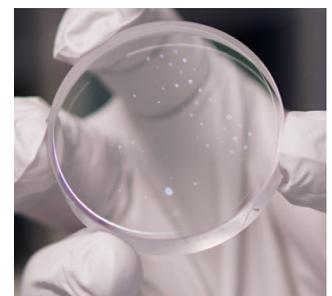
FIGURE 1: CHARACTERISTIC DAMAGE CURVE ACCORDING TO ISO 21254-2, TEST SITES DISTRIBUTION AND TESTED SAMPLE

FIGURE 1 depicts a typical result of such test, which describes LIDT dependence on the number of pulses. The test gives a value, which may be related to the intrinsic damage threshold of the surface and can be used as a performance criterion for choosing the most suitable coating material and production technology. Note, that only a fraction of a tested site surface is exposed to the laser beam. ISO 21254 standard specifies required distance in multiples of a beam diameter among exposed sites to prevent the interference of results with debris ejected from damage craters. This means, that the s-on-1 test has a fairly low probability to activate sparse damage precursors.

A manufacturer of optical thin films and thin-film based components is interested in his product performance, a single value that allows him to compare different coatings and coating processes, and thus the ISO 21254-2 standard procedure called "s-on-1" could be applied. This procedure utilizes extrapolated damage probability from measured data to show the damage threshold fluence in relation to number of pulses per so-called "characteristic damage curve".
